# Walk Around

## Focke-Wulf Fw 190A/F

Walk Around Number 22  
squadron/signal publications

By Malcolm Laing and E. Brown Ryle

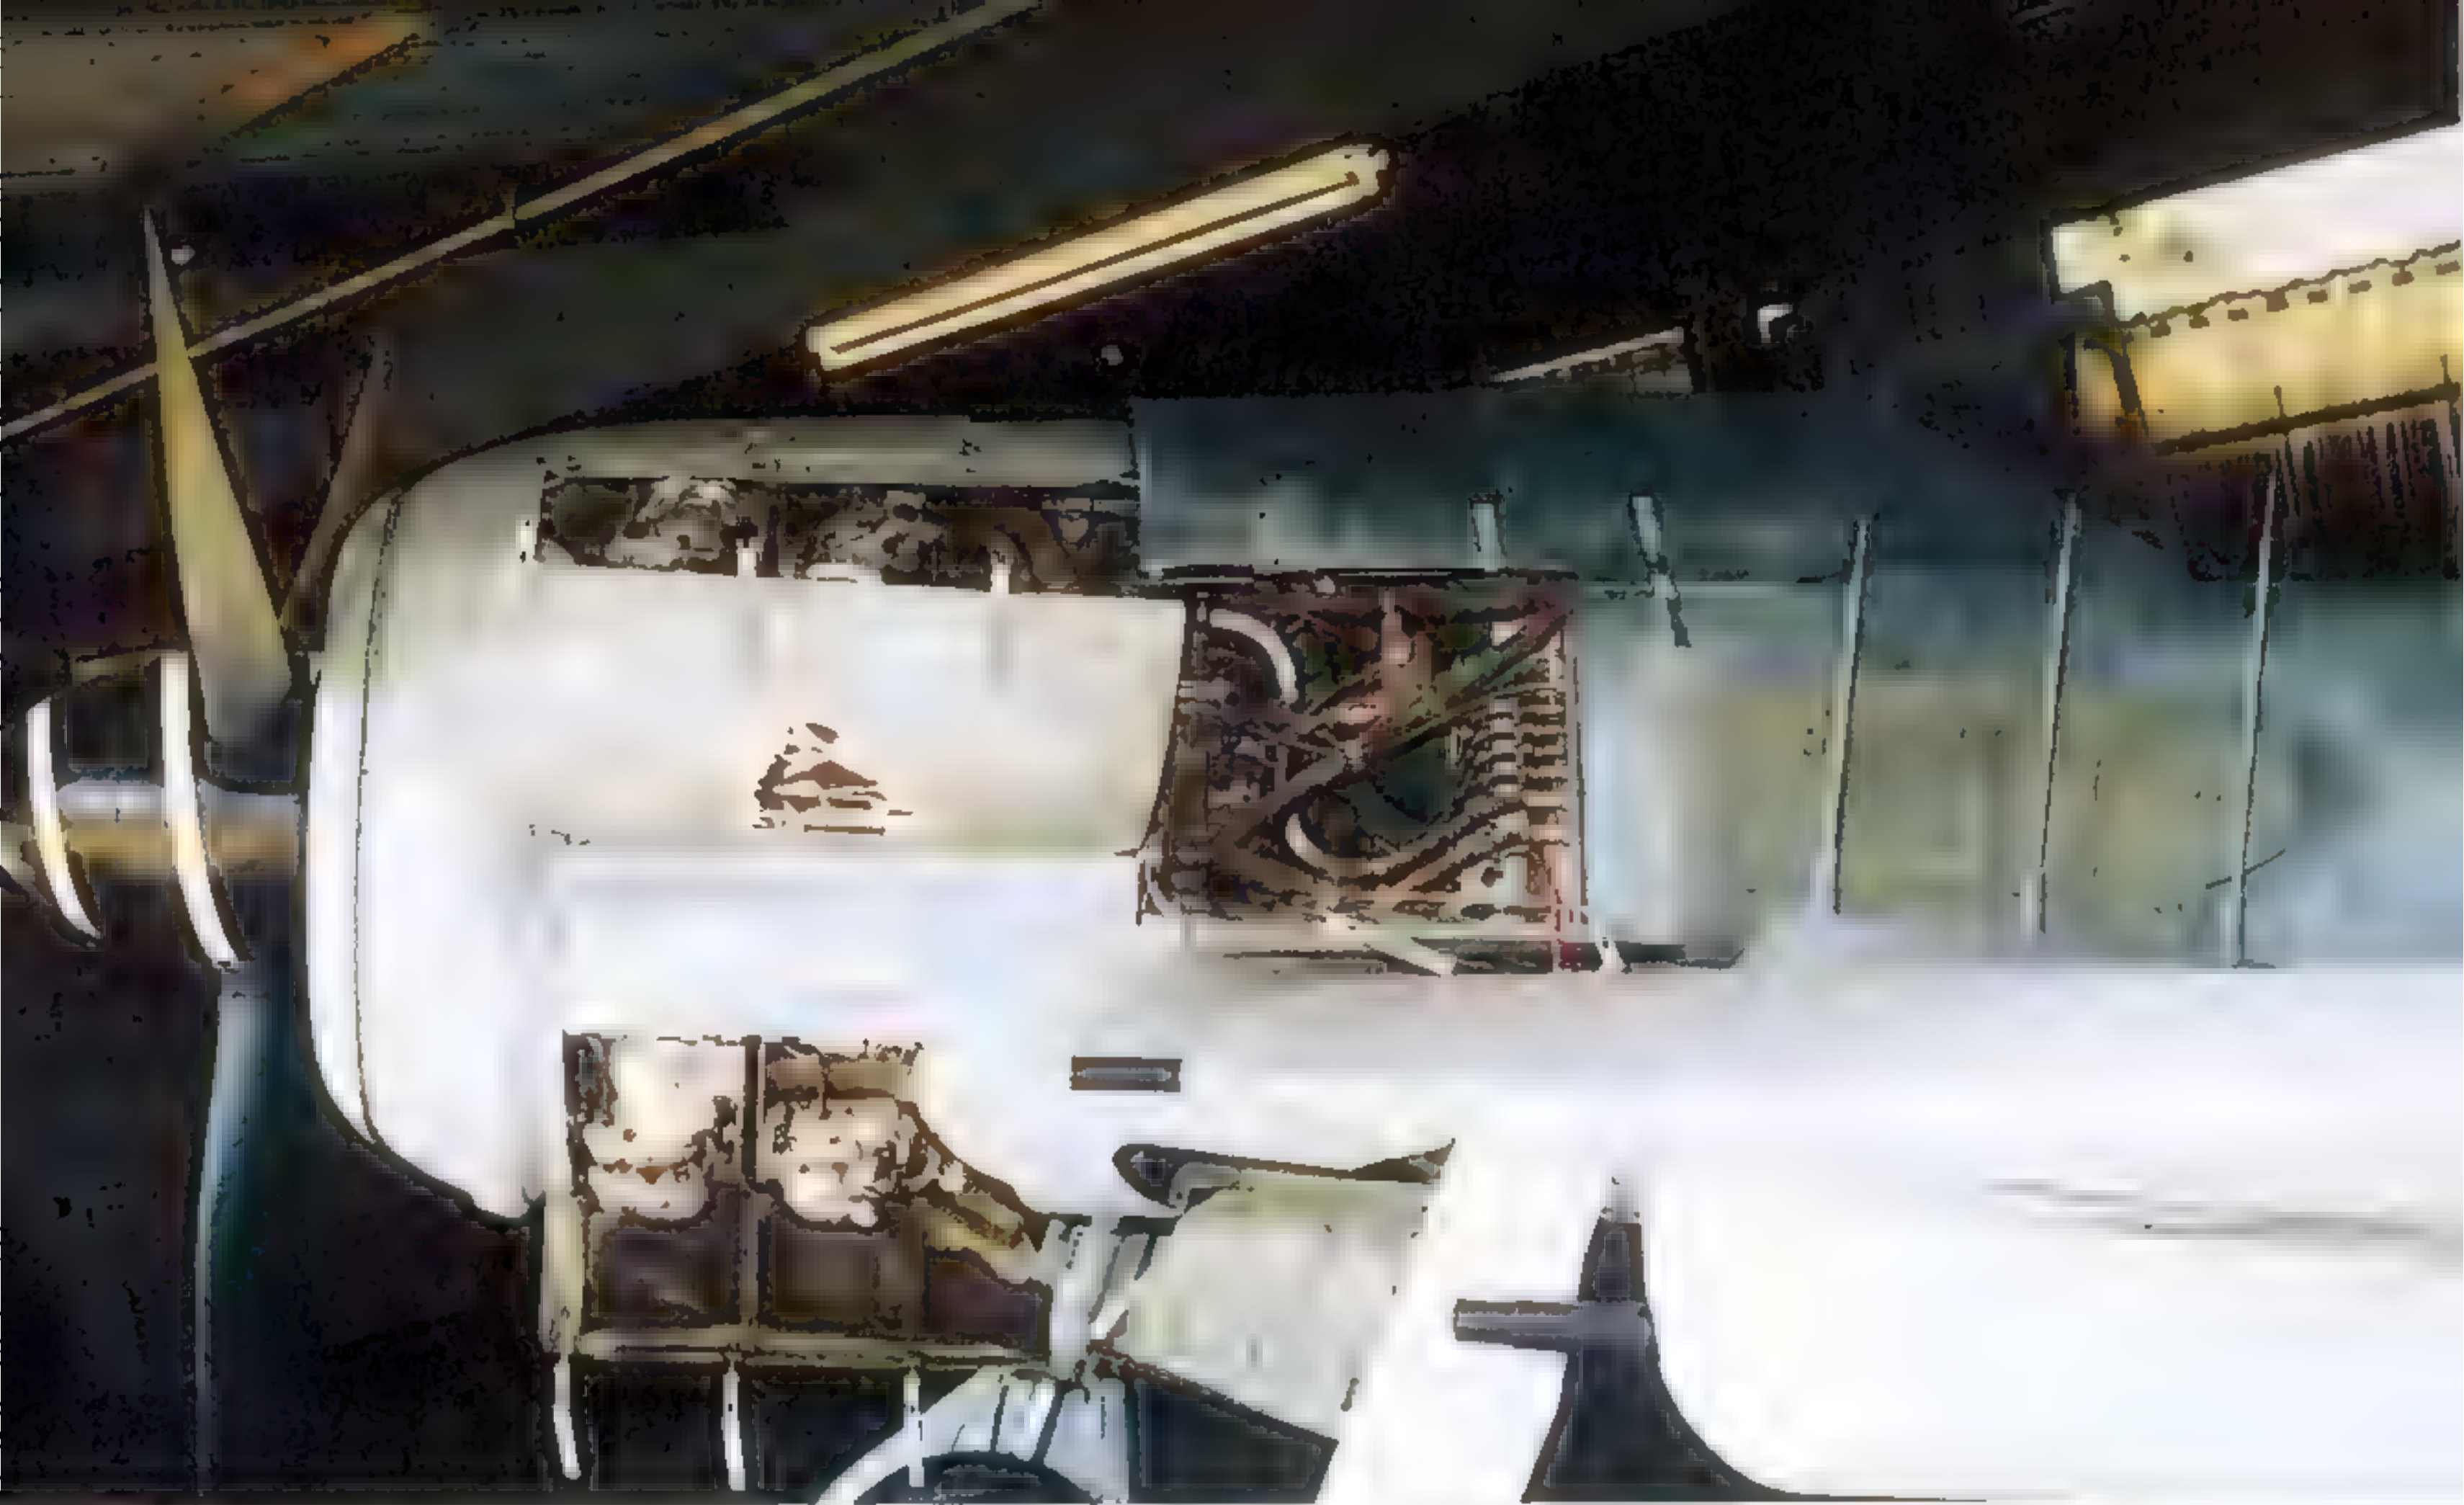
(Above) The port engine cowling door, once opened, was held in place by two restraining wires running from the top of the engine opening. The starboard cowling door is identical. Exhaust from four engine cylinders each came out the port and starboard fuselage, while the remaining six exhaust stacks were ducted under the fuselage. The engine exhaust panel was often painted black to hide the exhaust stains. (Molnar & Hugo)

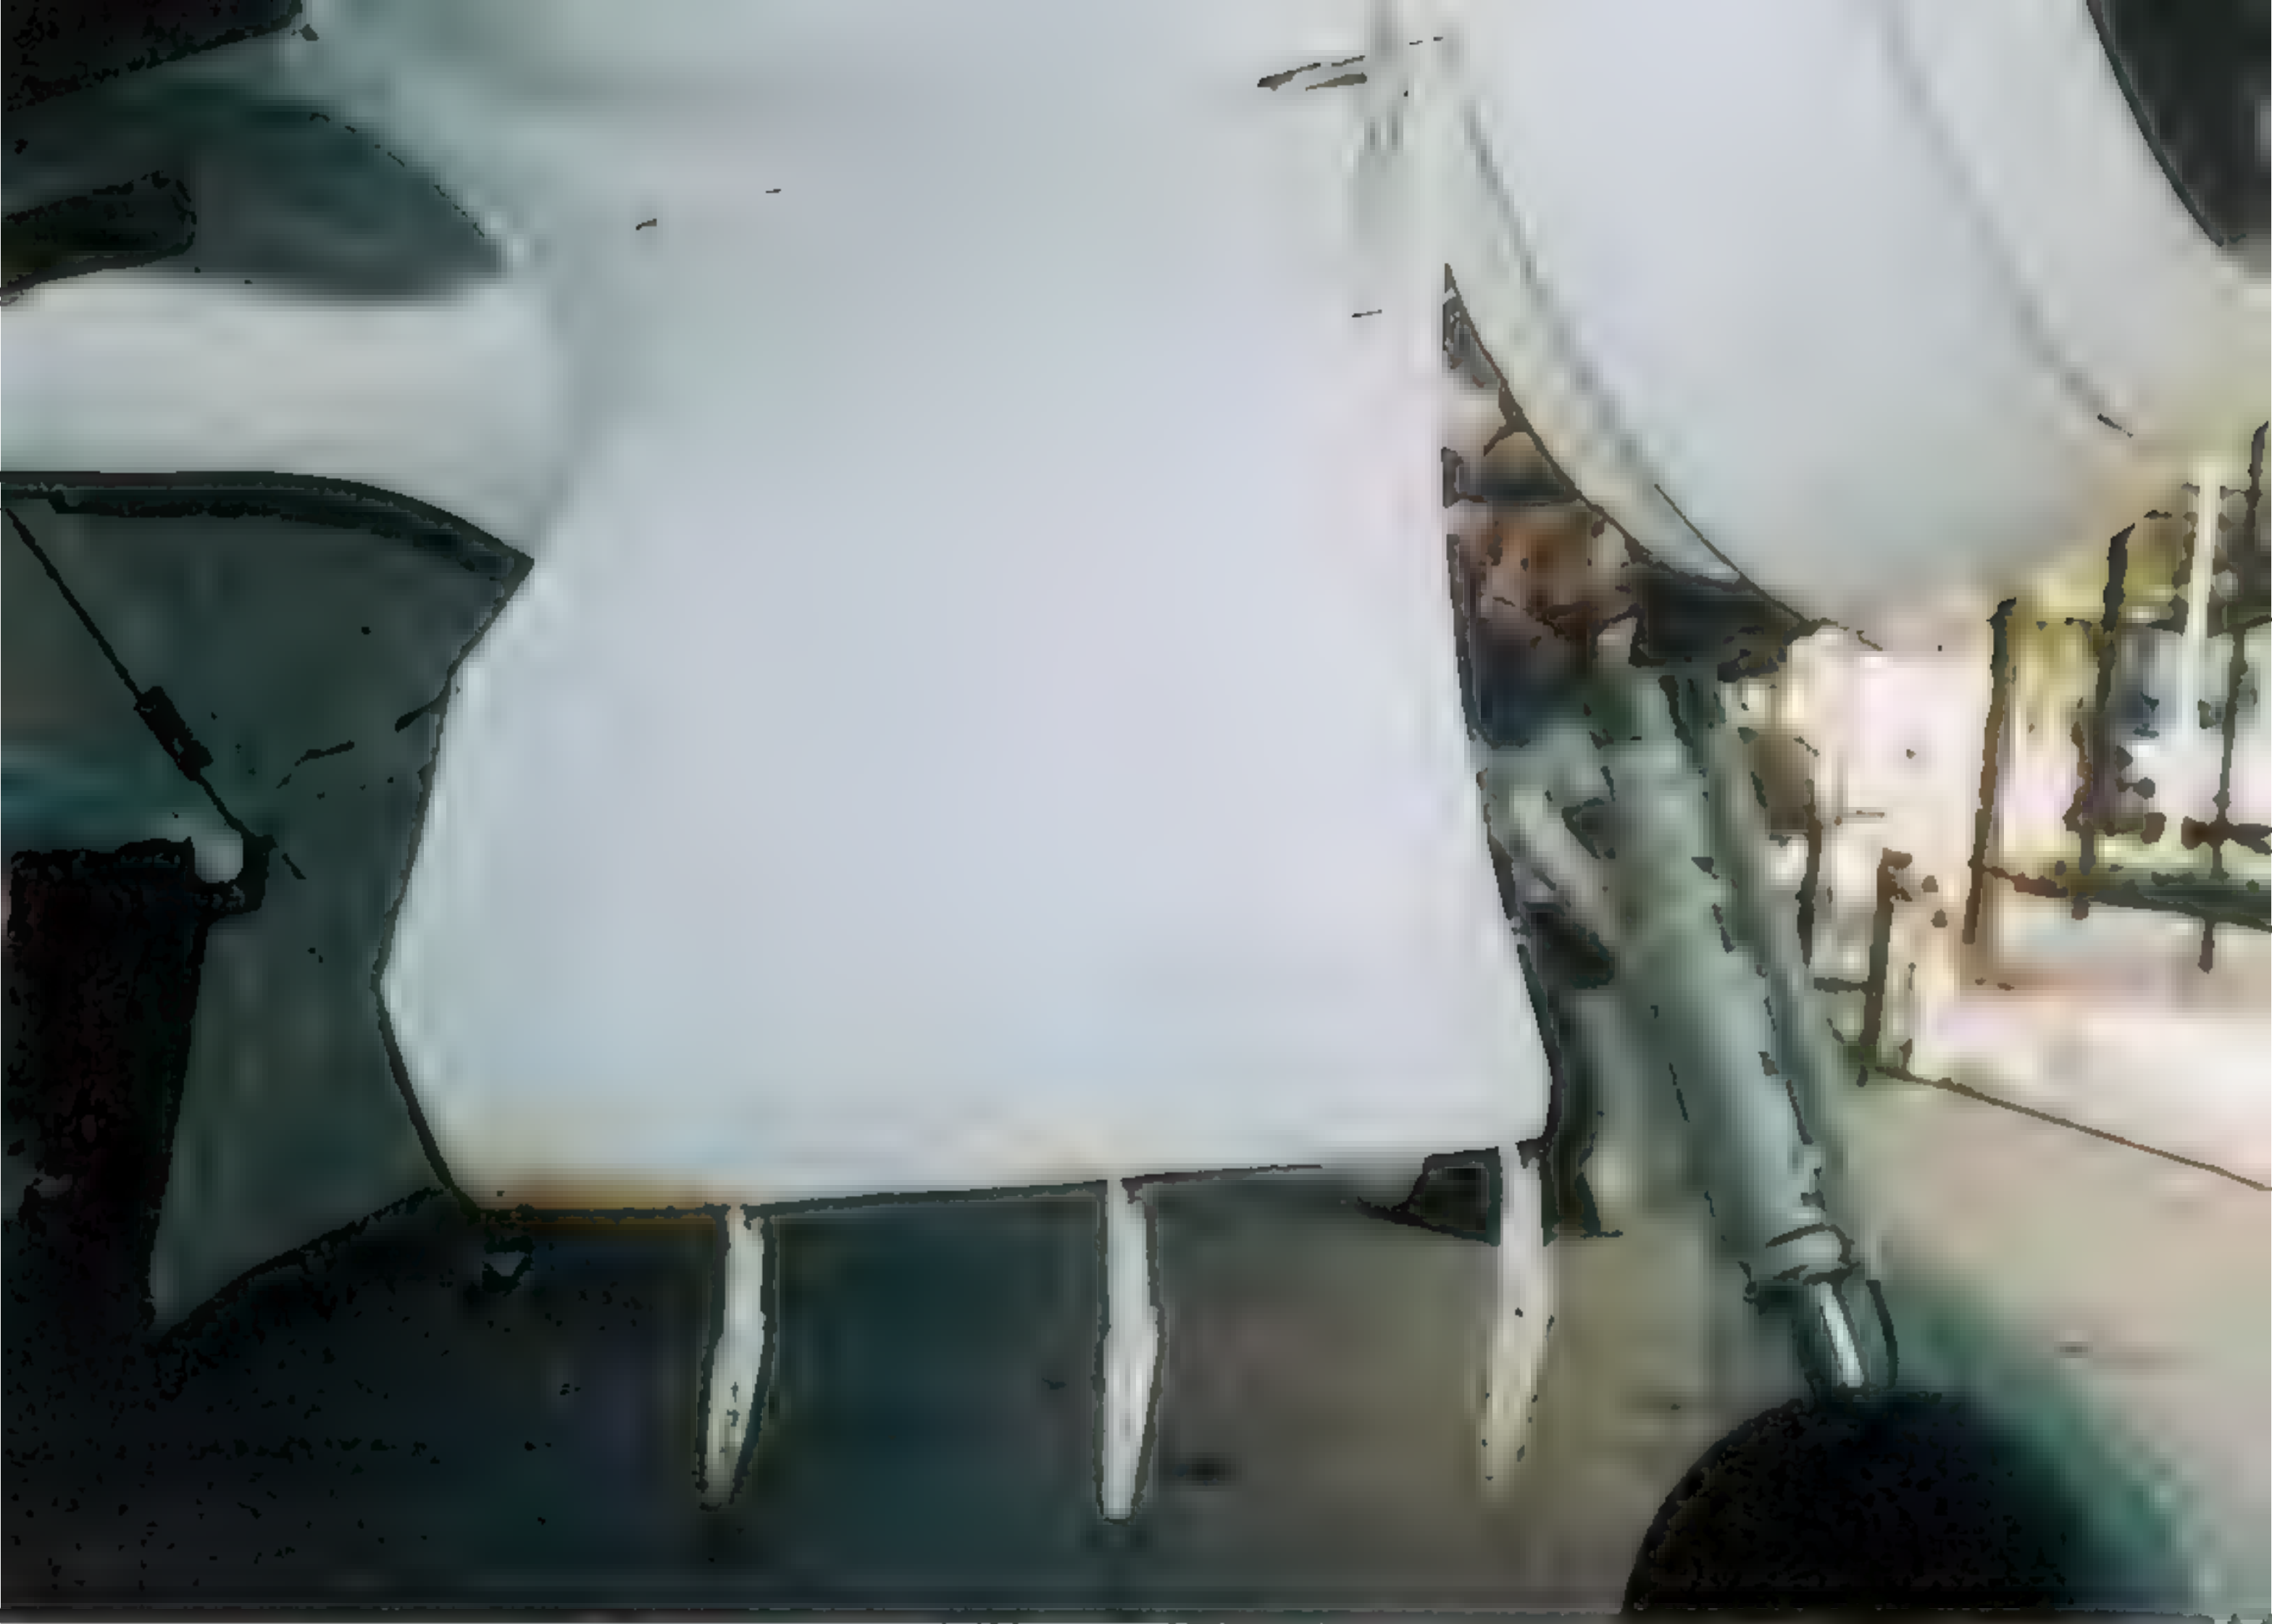
The underside engine access door was fastened to the cowling by three latches on the bottom and one latch at the top. The Fw 190's access doors swung on piano hinges, which allowed for minimal aerodynamic drag while enabling a wide degree of travel for the panel. The rod in this hinge was removable to allow the complete removal of the access door. (Molnar & Hugo)

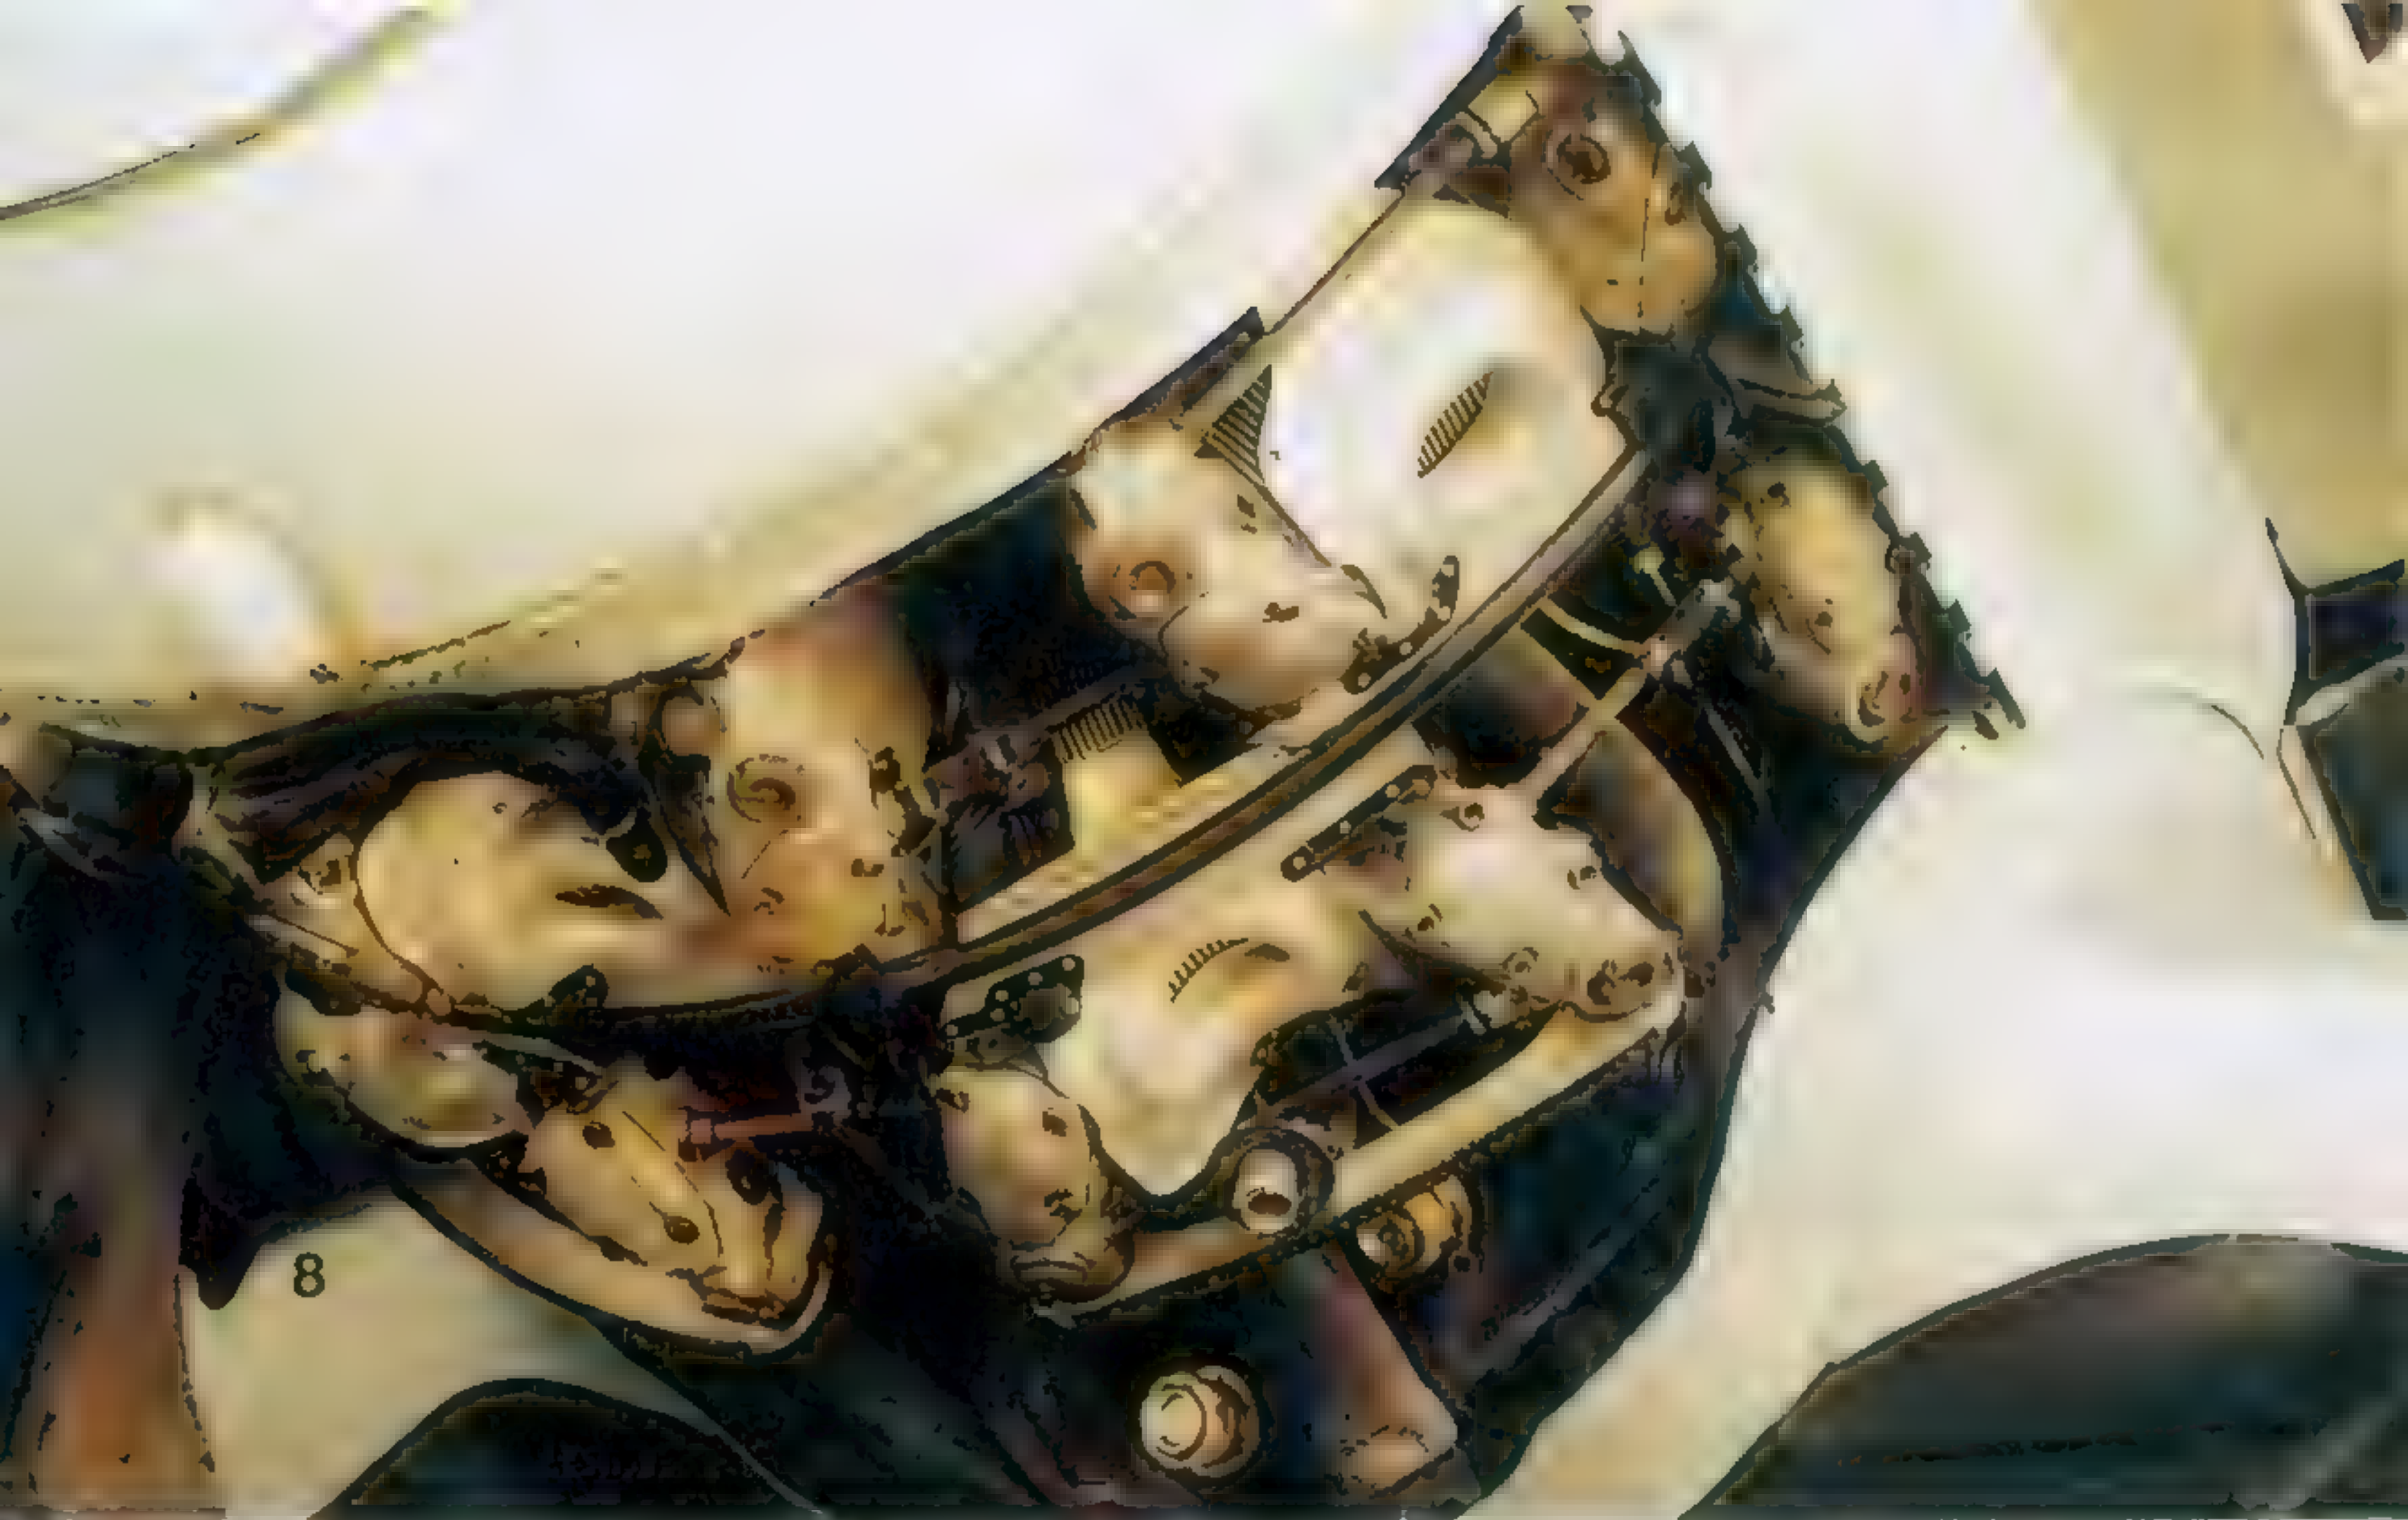
Access to five of the BMW 801 engine's 14 cylinders was through the lower engine access door. The exhaust pipes for these cylinders were located under the engine on the aircraft's centerline. The tightly fitted engine cowling of the Fw 190A reduced drag for improved performance over rival radial-engine fighters. (Molnar & Hugo)

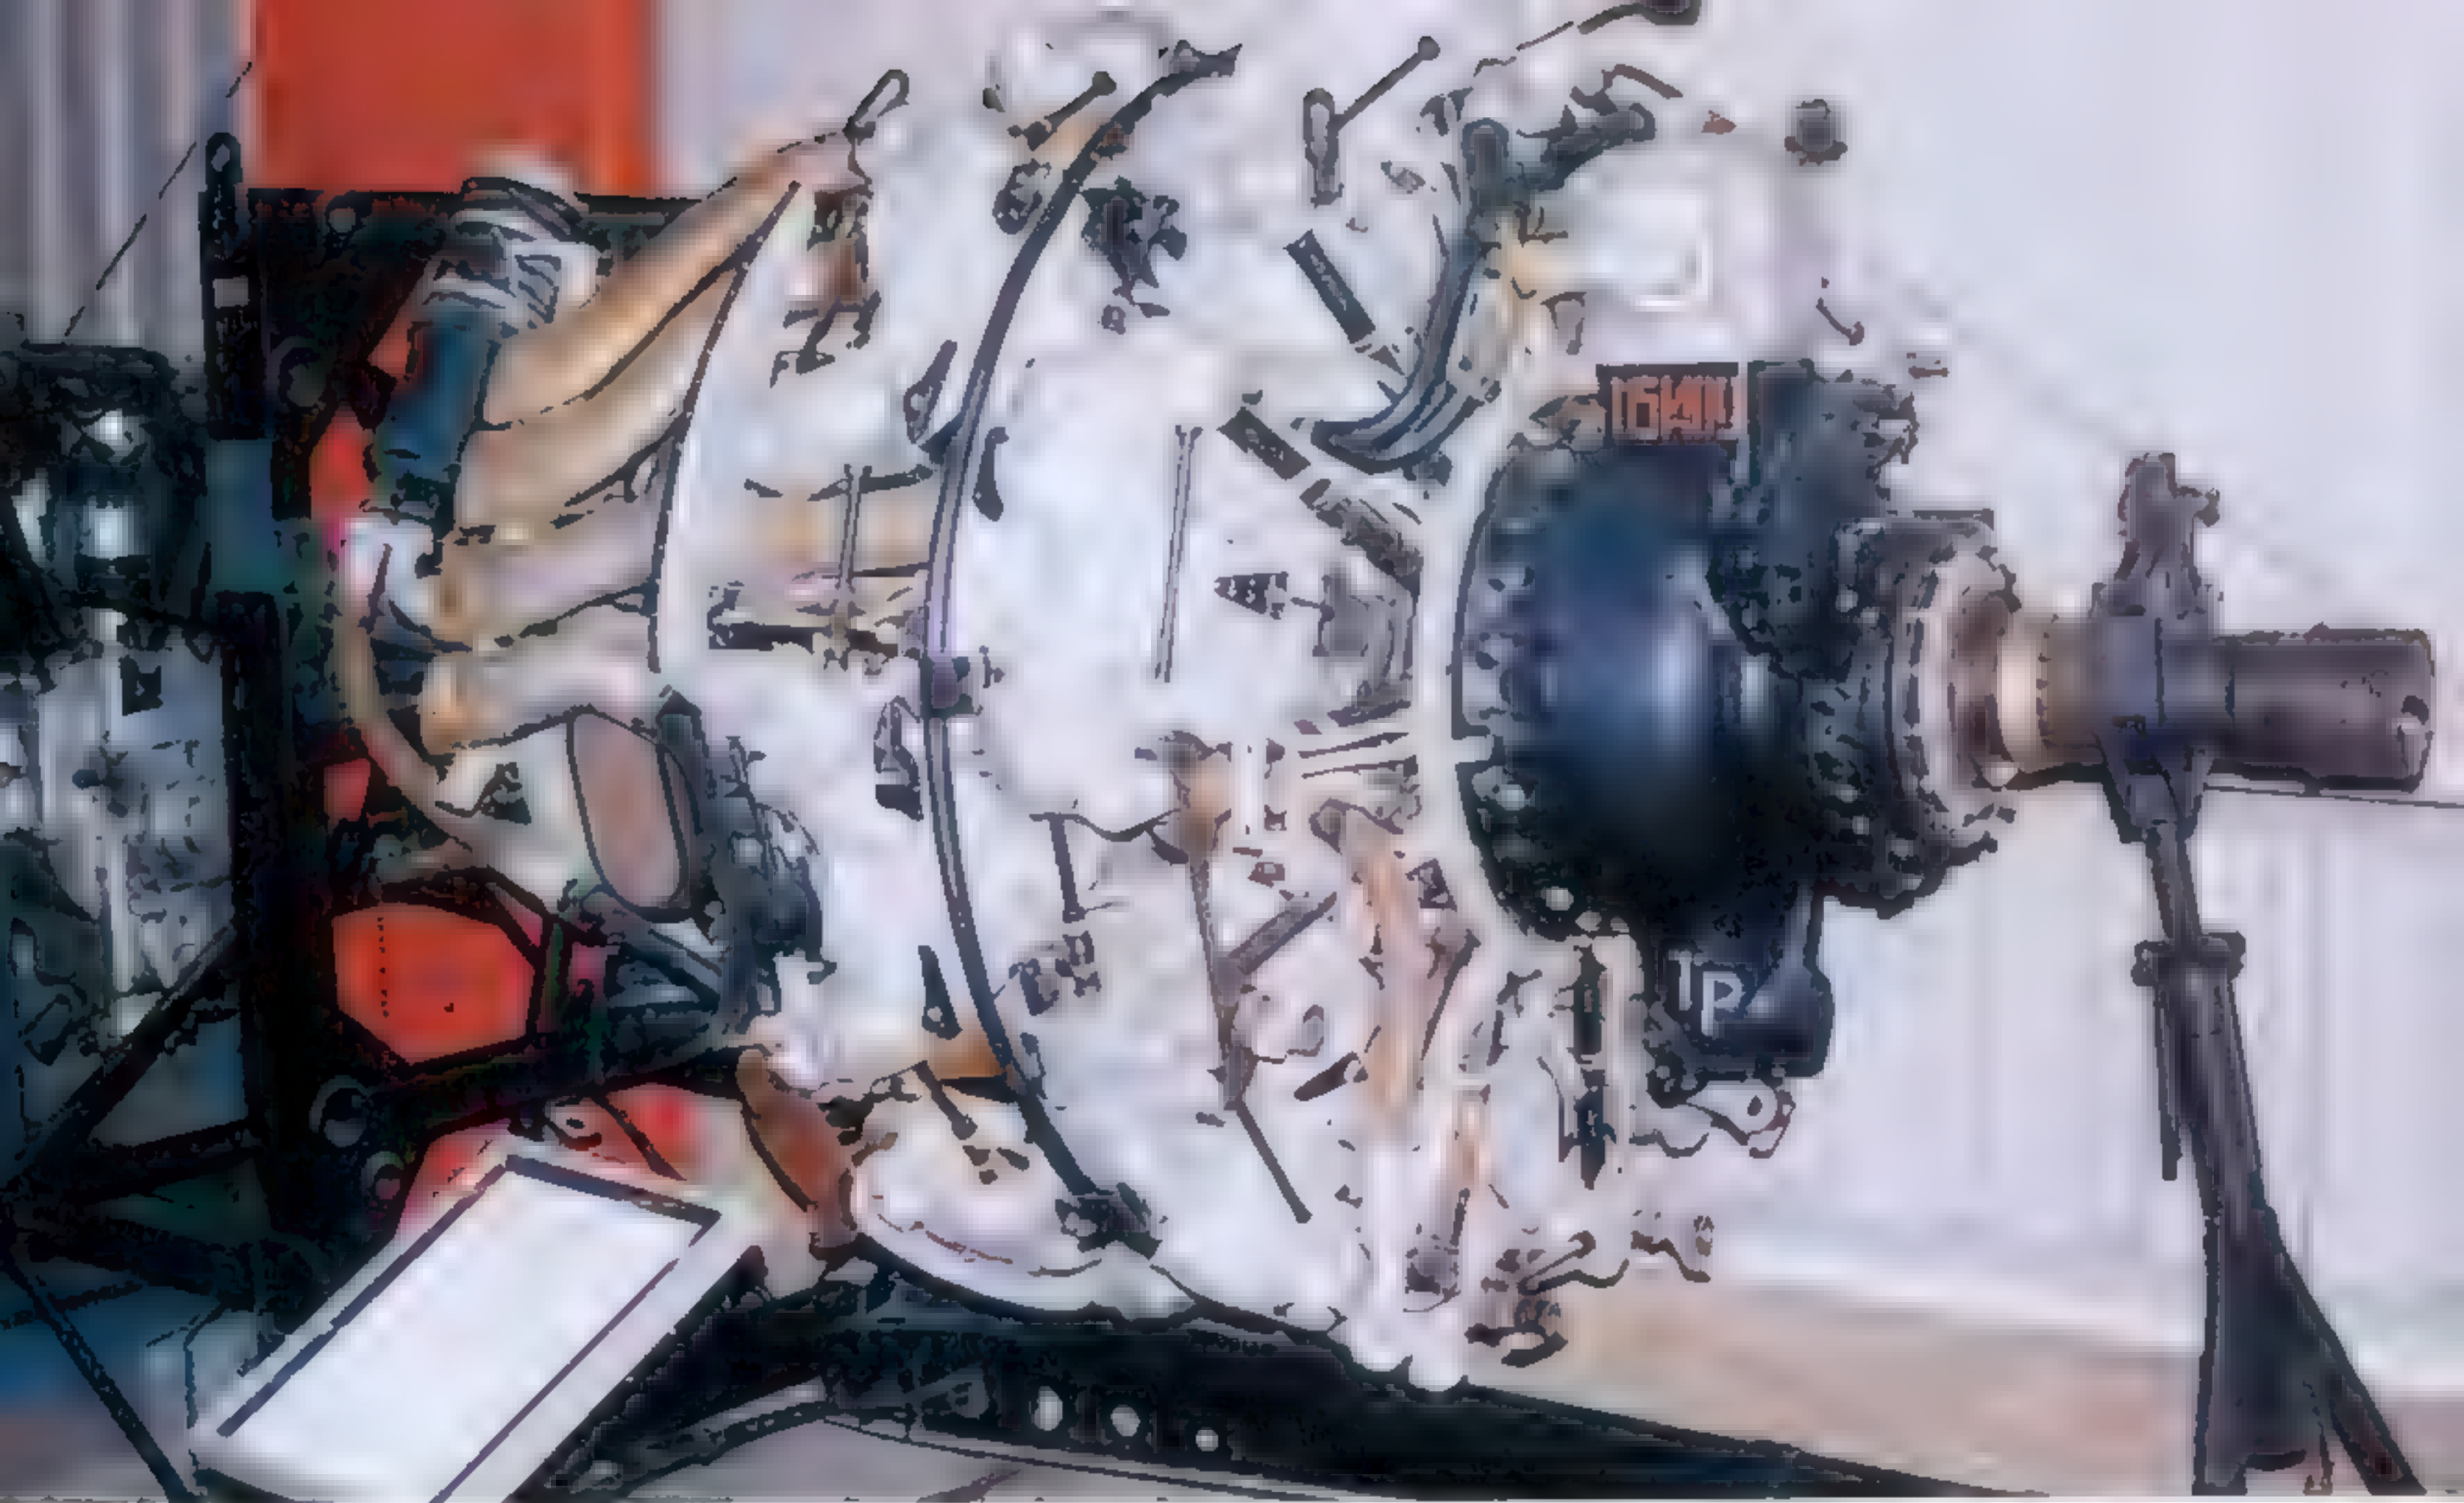
## BMW 801D-2 Engine

The BMW (*Bayernische Motoren Werke*; Bavarian Motor Works) 801D-2 engine powered the Fw 190A, F, G, and S series. The magneto is mounted on top of the gear housing on the front of the engine. The engine serial number (1151409) is stenciled on the upper side of the gear housing. (Fochuk)

Type:	Air-cooled, 14-cylinder two-row radial
Horsepower:	1,730 HP at take-off
Displacement:	2,562 cu in (42 liters)
Bore:	6.14 in (156 mm)
Stroke:	6.14 in (156mm)
Compression ratio:	7 to 1

Fuel:	German C3 (100 octane)
Valves:	One inlet, one exhaust valve per cylinder
Valve Springs:	Three per valve
Ignition:	Dual – two Bosch ZM 14 magneto generators
Spark Plugs:	Bosch DW 240 ET 7 or Siemens 35 FU 14 two-electrode 14mm plugs, two per cylinder

Weights:	
Power Unit:	2958.6 lb (1342 kg) complete engine section
Propeller:	390.2 lb (177 kg)
Nose Bowl:	251.3 lb (114 kg) oil cooler & tank, armor, & breather valves
Cowling:	99.2 lb (45 kg) excludes nose bowl
Cooling Fan:	20.5 lb (9.3 kg)

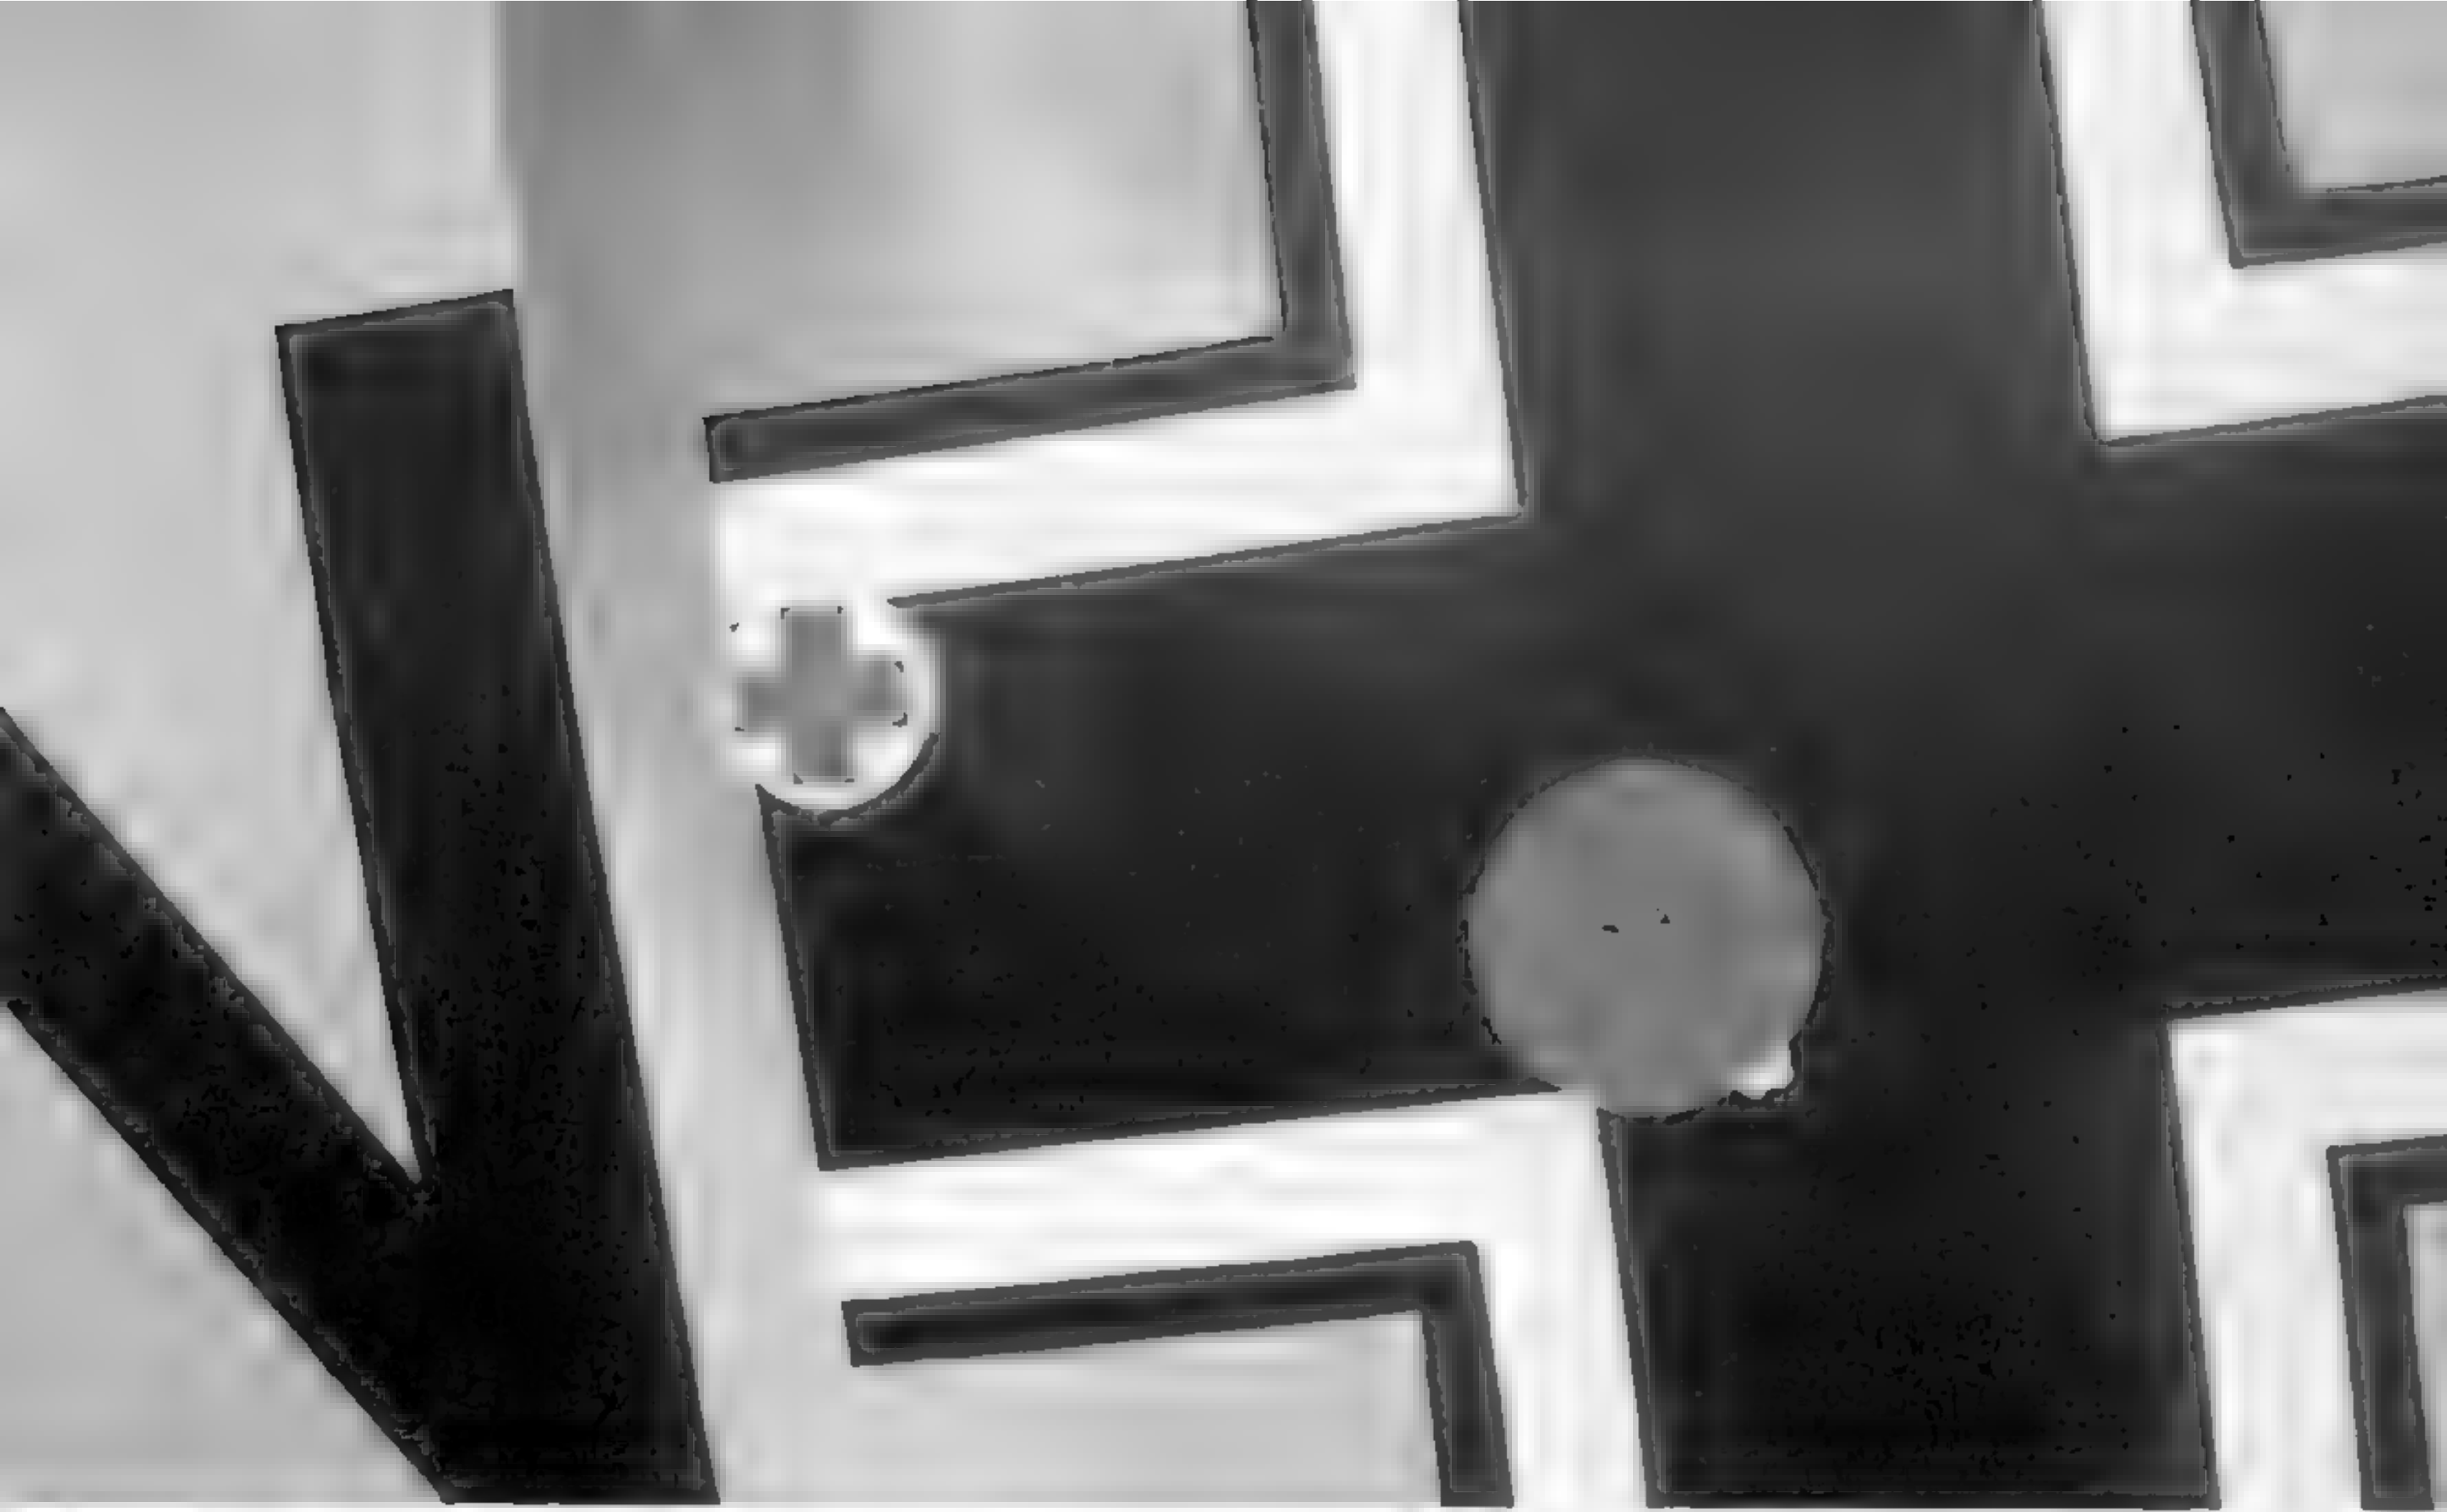
The red cross painted on a white circle indicated the location of a first aid kit behind the small starboard fuselage access door. The solid red circle inside the black cross covers the external 24V power-supply socket. (Molnar & Hugo)

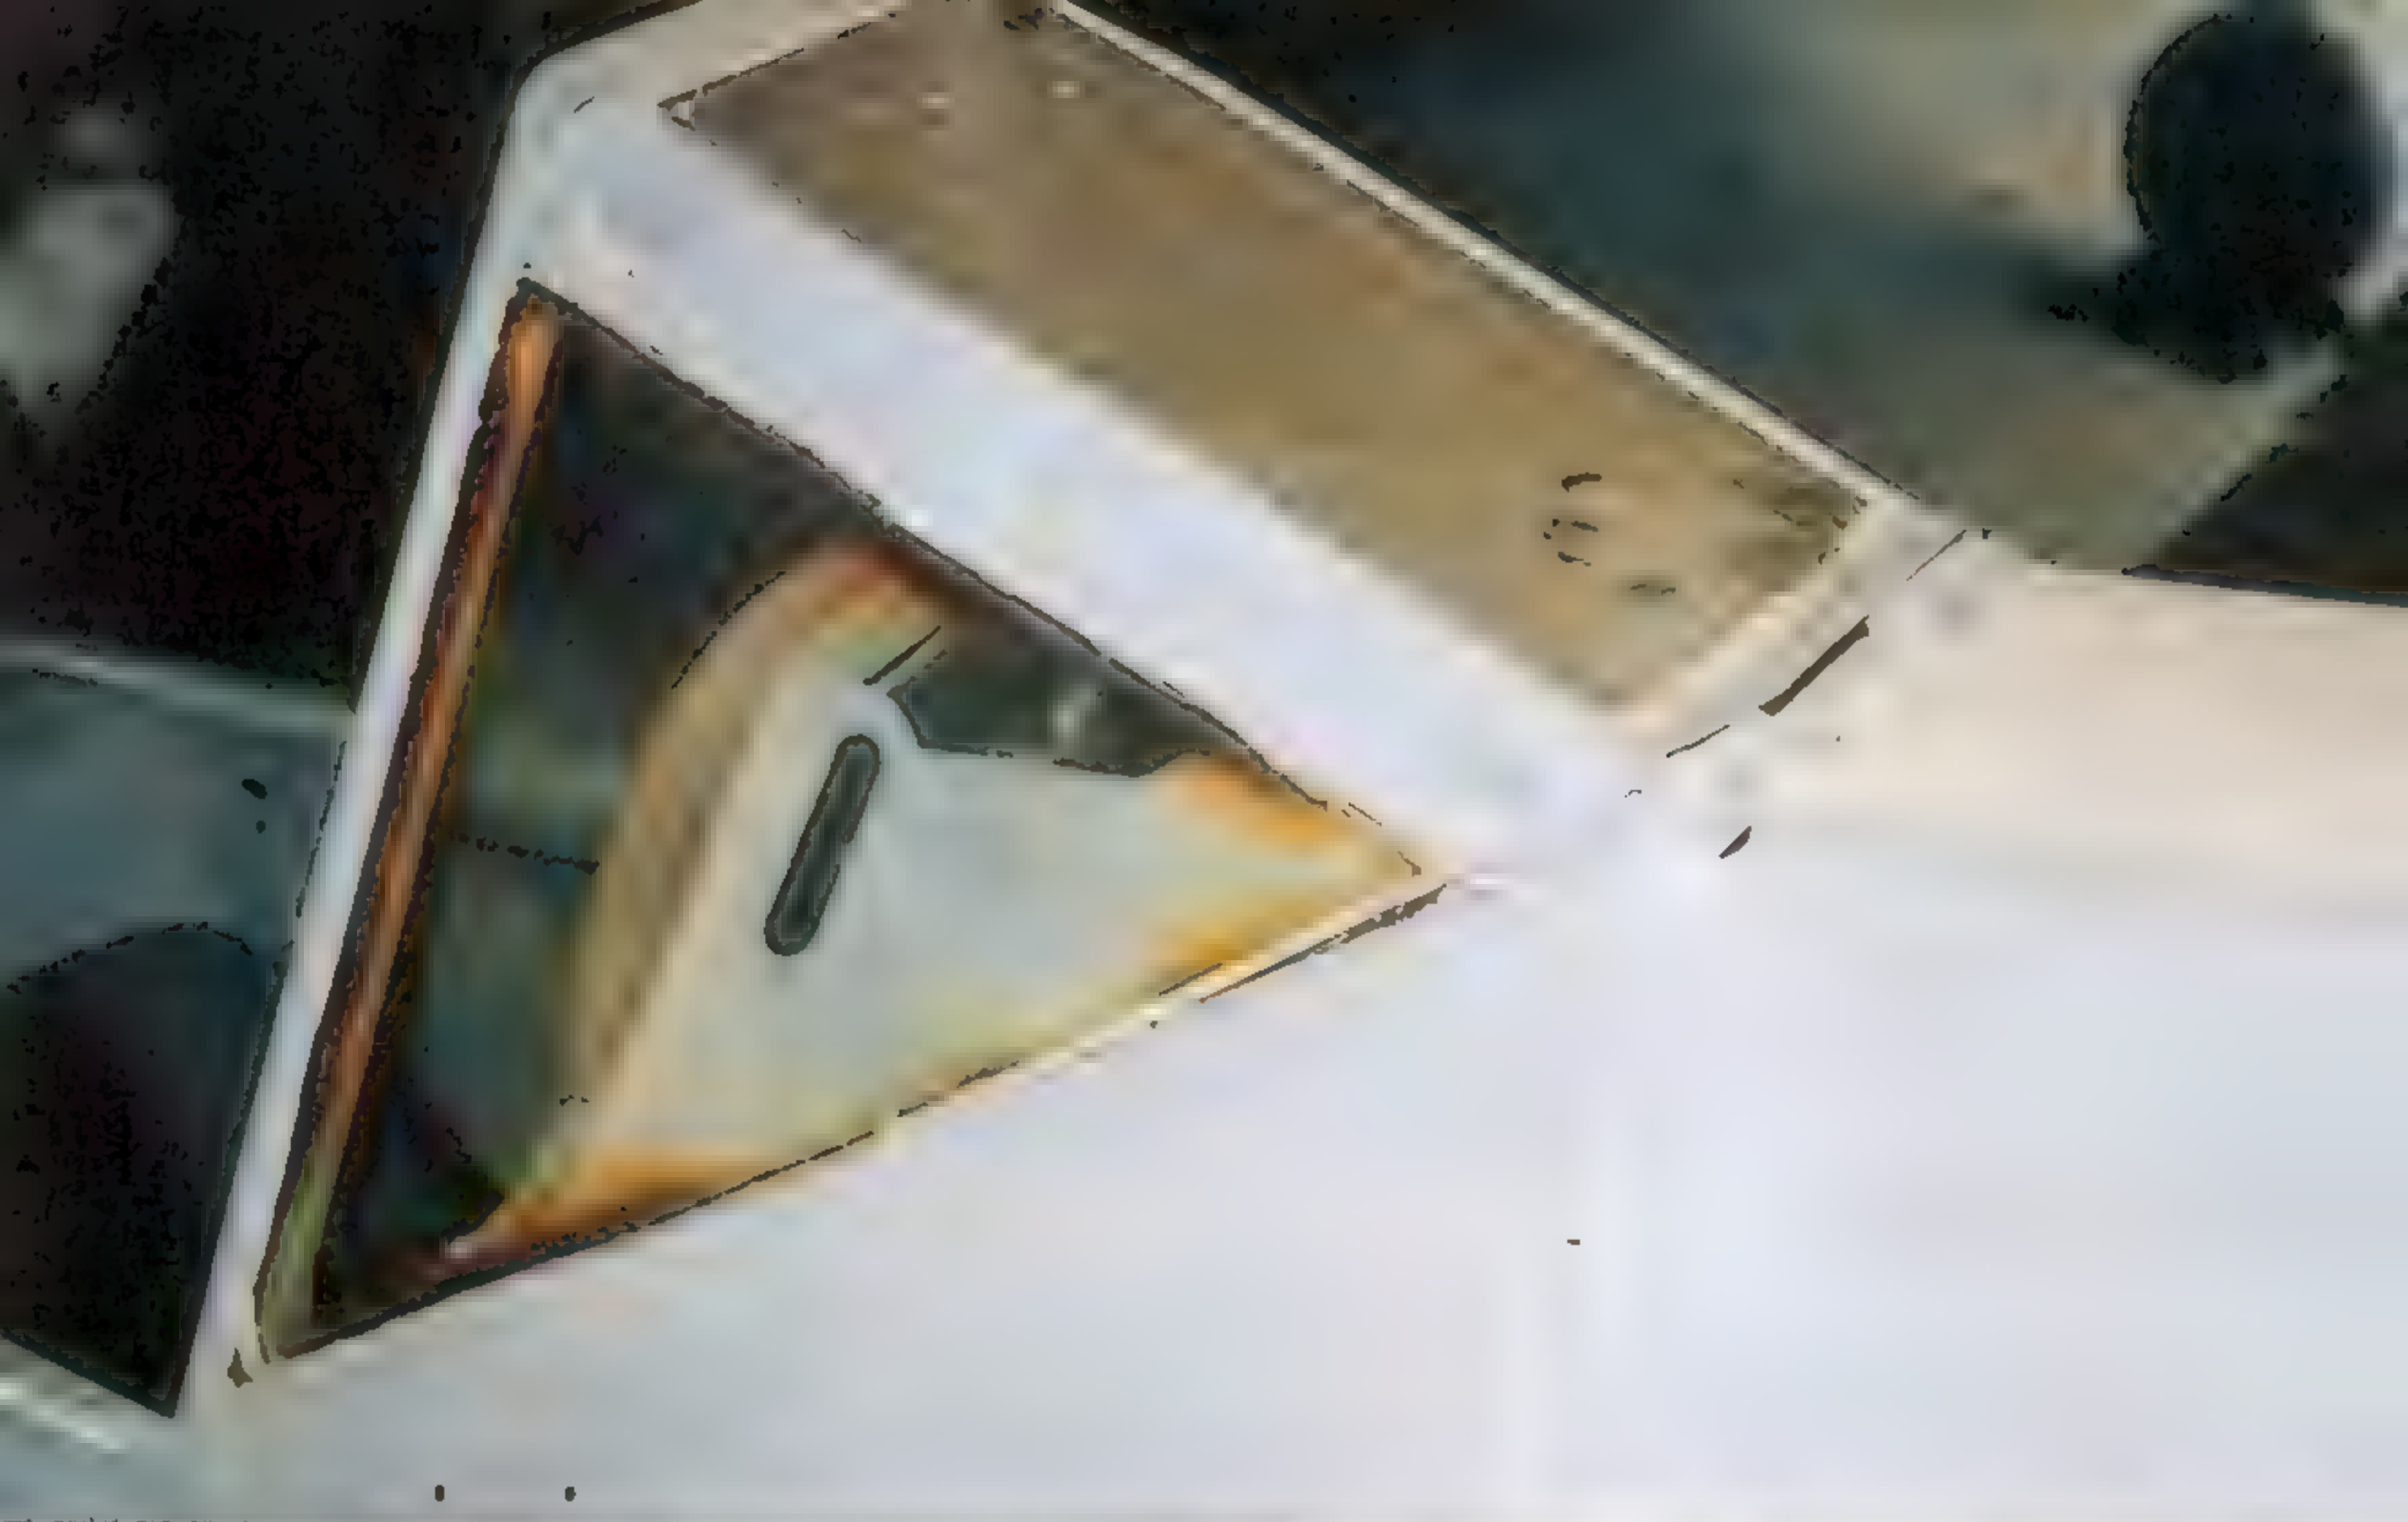
The Fw 190A-6 armored windshield's molded frame was attached with a two-one-two bolt pattern. The piping for the windshield deicing system was installed on the base and forward sides of the windshield, and were fed with fuel drawn from the cockpit 'wet line' fuel pressure gauge just prior to the fuel entering this gauge. A rectangular hand grip is placed in the starboard instrument shroud. (Molnar & Hugo)
